Manhole Inspection Summary

Manhole # S11C1_008MH

Insp Date: **1/8/09 11:23 AM**

Location Address: **1401 Bloomfield Ave.**

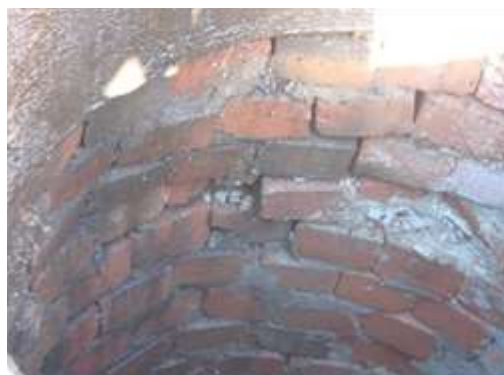
Defect 8

missing mortar causing corbel infiltration

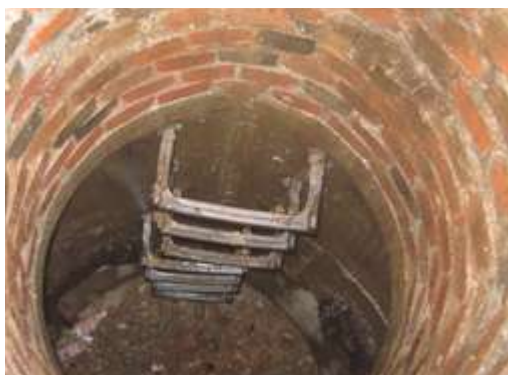
Defect 7

corbel and barrel infiltration

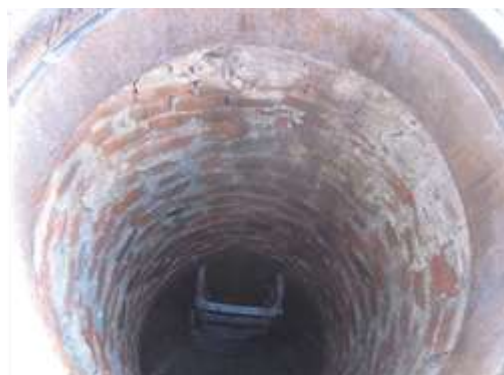
Defect

Chimney loose bricks

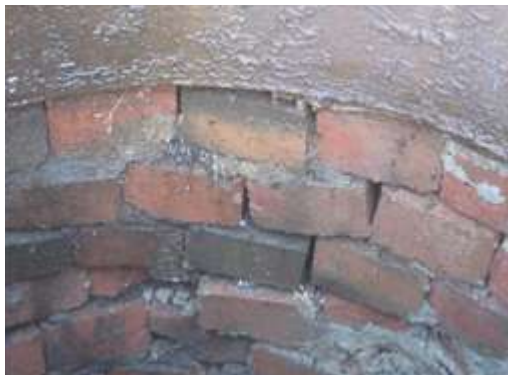
Defect 6

missing mortar causing infiltration and also root intrusion

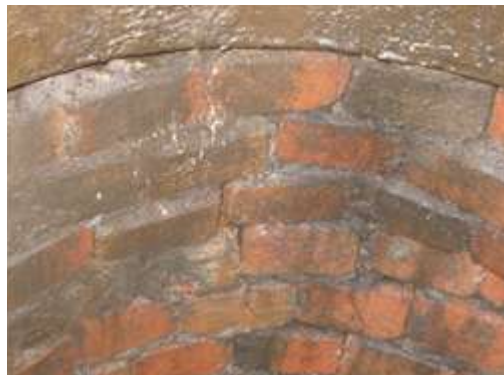
Defect 5

missing mortar causing chimney infiltration and root intrusion

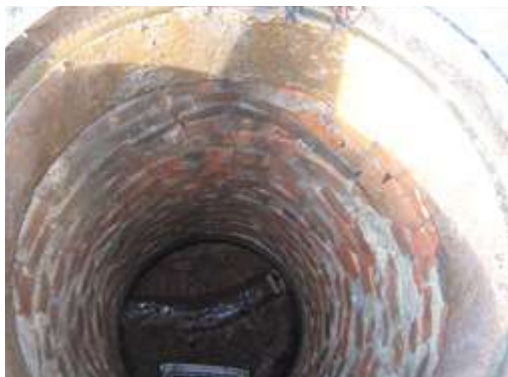
Defect

Frame leaks

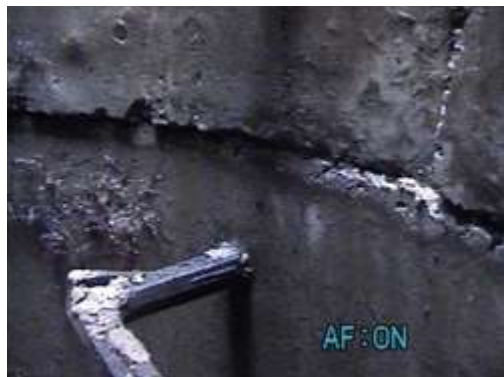
Defect 4

barrel infiltration at joint

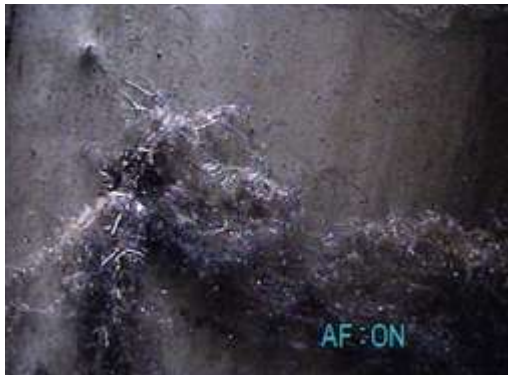
Defect 3

barrel infiltration and root intrusion

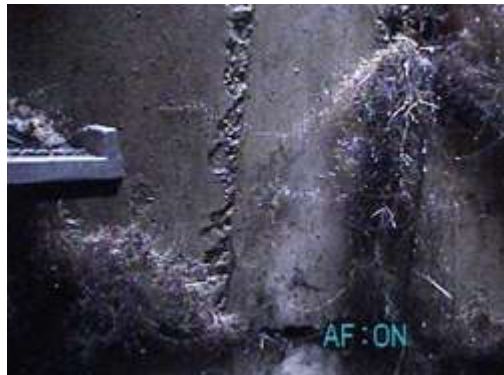
Defect 2

root intrusion and infiltration at barrel

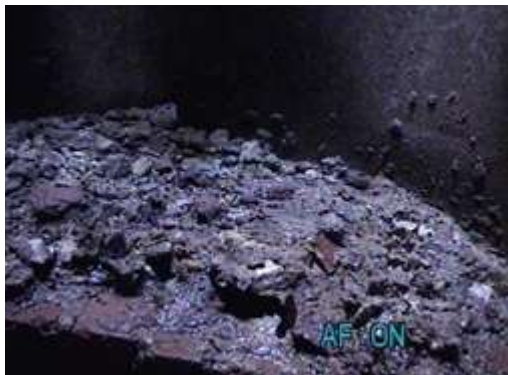
Defect 1

debris on the bench
